# Ballistic Perforation of Graphite/Epoxy Composite

December 1996

# Special Report 96-29

## **Ballistic Perforation of Graphite/Epoxy Composite**

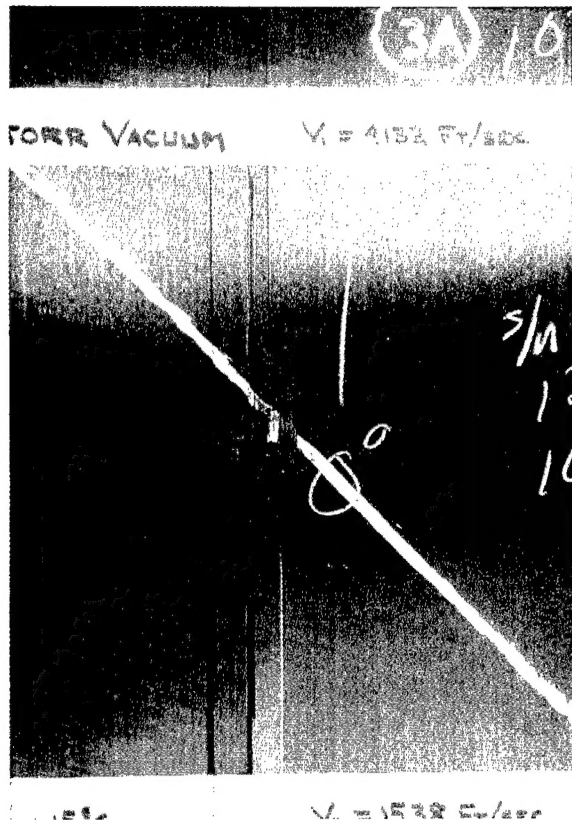
Figure 3. Typical specimen of the unidirectional Gr/Ep specimen after test.

The damage in the unidirectional laminate was simple to interpret. Because of severe anisotropy of the stiffness and strength properties, only longitudinal cracks in fiber direction propagated. The primary failure in the impact zone was obviously indentation followed by fiber breakage, delamination, and finally shear plugging. Numerous longitudinal cracks split the specimens in a large number of longitudinal strips (Fig. 3). Figure 5 shows the effects of velocity on the damage process of the unidirectional Gr/Ep. Notice that the shear plug-out hole for the high-velocity impact (approx. 4500 ft/s or 1400 m/s) has a much cleaner outline (Fig. 5a) than the one at lower velocity (Fig. 5b). It seems likely that at higher velocities more momentum is trapped in the shear plug than at low velocities. At lower velocities the fibers break upon impact of the projectile, and then flex with shear failures propagating longitudinally to the boundaries of the specimens.

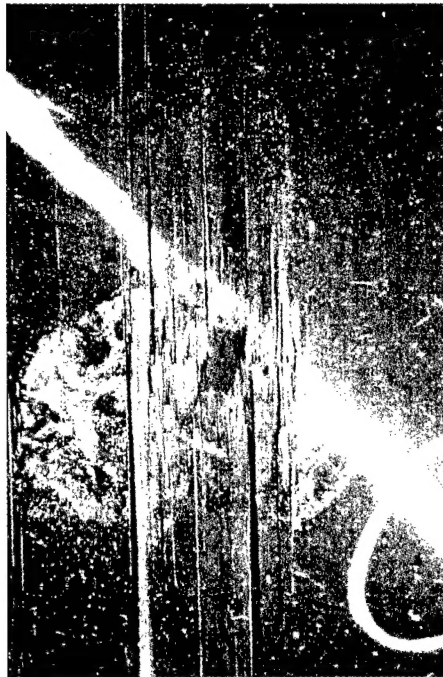
*a. High velocity: shear plug out.*

*Figure 5. Effect of velocity on the damage of unidirectional Gr/Ep plates.*

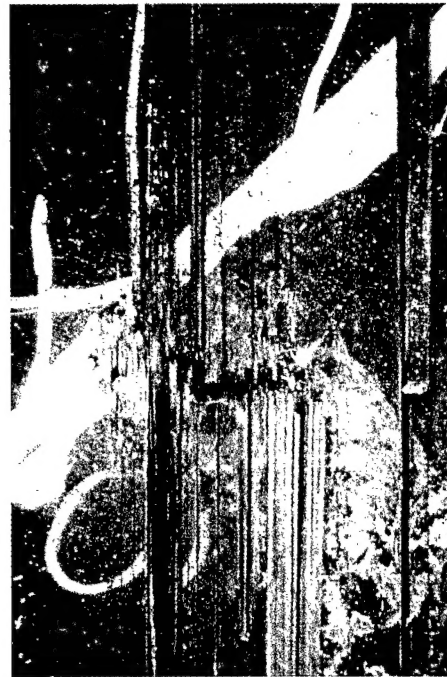
*b. Low velocity: no shear plug-out.*

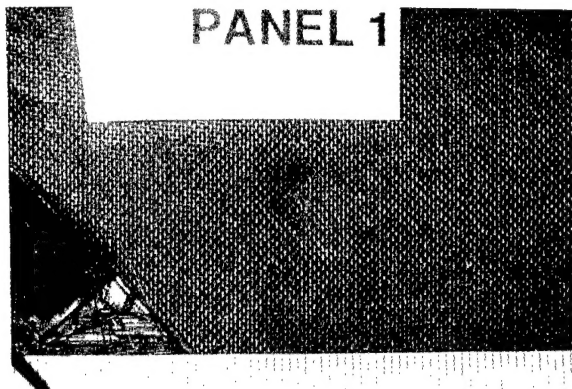
Figure 6a shows a very low velocity (88.4-m/s, 291-ft/s) impact of the steel ball on the 30-ply Gr/Ep laminate. The energy of impact in this case was not sufficient to cause perforation. (Ballistic tests

performed at the U.S. Air Force Wright Laboratory\* show that the  $V_{50}$  velocities for this type of laminates would be about 137 m/s [450 ft/s].) Nevertheless, damage by delamination and fiber breakage did happen as evident from the slight bulging of the rear surface and an ultrasonic scanning (C-scan) examination performed on this laminate. At velocities around  $V_{50}$  a typical damage looks like the one shown in Figure 6b, which was obtained at 151 m/s (496 ft/s). The perforation was complete in this case. The high velocity (975-m/s, 3200-ft/s) perforation type damage on these laminate was rather extensive. Figure 4 shows a cut-out section through the perforation hole of the high velocity impact. The cutout was carefully made without disturbing the positions of broken lamina and fibers. Notice that the damages on both impact and exit sides are more extensive than at the center. Delamination damage is more in the rear side, whereas the impact end has more crushing and fiber breakage.

*a. Low velocity impact damage (unperforated).*

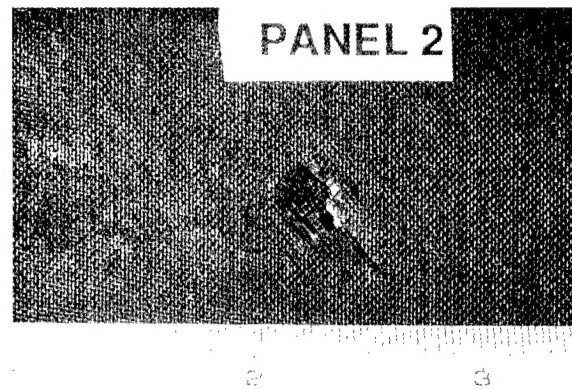
*b. High velocity impact damage (unperforated).*

*Figure 6. Impact damages to quasi-isotropic composite plates.*

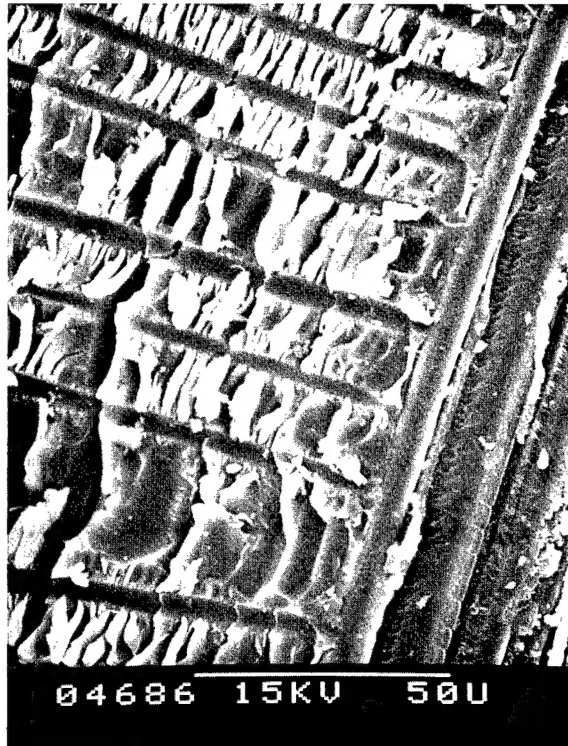
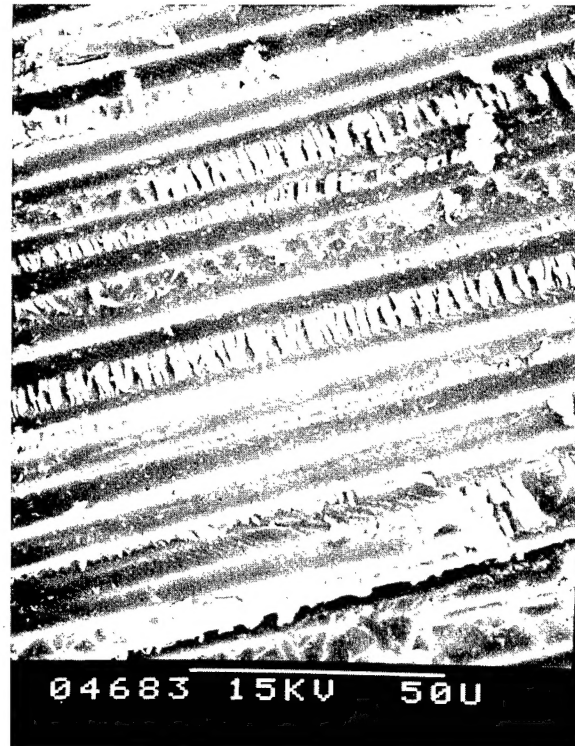
seemed to contain interlaminar joint surfaces. Fibers oriented in  $45^\circ$  and  $90^\circ$  angles are clearly visible in these fragments. Many of the samples in this category of tests showed hackle marks (Fig. 7a, b).

*Figure 7. Very high velocity impact fragment fracture surfaces.*

hackle marks in fracture surfaces would primarily indicate an impact induced damage, and proliferation of hackle marks on our ballistic fragments clearly indicates this trend (Fig. 7 a, b).

The hackle marks present a periodic formation of sigmoidally shaped ridges and troughs running roughly parallel to the fiber direction and located in the matrix region between them. There is a spatial periodicity perpendicular to the direction of the fibers, which is the first suggestive observation. The second observation is that the wavelength of these hackle marks appears to increase as the distance between the neighboring fibers increase (Fig. 7a). The wavelength of the hackle mark is of the order of the order of interfiber distance. Sometimes, the ridges appear to be canted at an angle to the fiber axis.
